## “The Path to Performance”

### Postings from a 2016 Energy Star Home Under Construction

#### ***HVAC, Electrical, and Plumbing ... Installation of Essential Infrastructure in a High-performance Home***

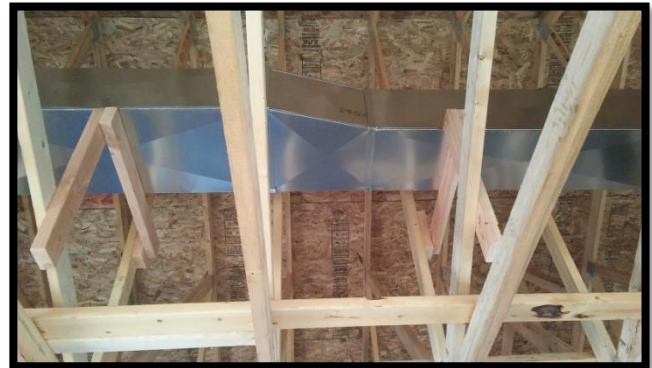
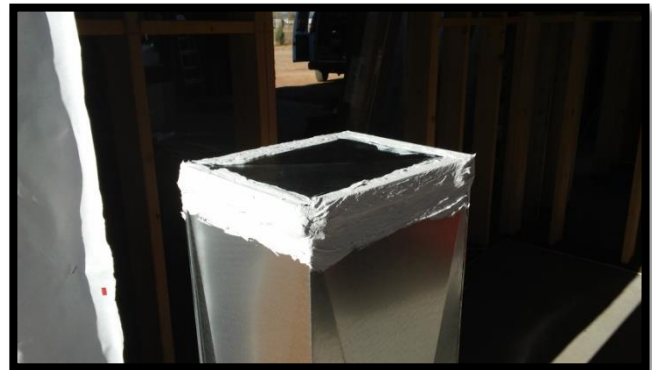
The ductwork and air handler portion of the split system was installed into what will be an unvented, conditioned attic space by technicians from [Cool Side Inc.](#) The main trunk line of the ductwork was

sheetmetal with flex duct branching off to supply conditioned air to individual ceiling registers throughout the house. Two air return plenums (master bedroom and service hallway) were also installed. Even though the ducts are in the conditioned attic space, all seams and connections

were sealed with mastic to limit air leakage that could create air pressure imbalances.

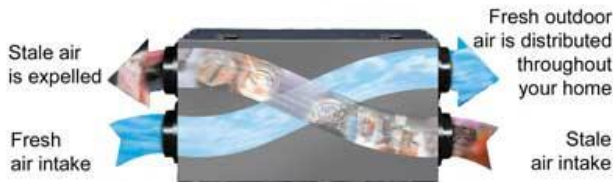
windows or other penetrations is minimized, indoor air quality must be maintained by other means. To accommodate this, Cool Side installed an Energy Star®-certified Venmar C12 Energy Recovery Ventilator (ERV). This unit draws in fresh air and expels stale air (from registers under the rear patio roof), while also tempering the air exchange temperature and filtering the air.

When in operation, the unit typically operates 20 minutes per hour programmed via a control unit on the wall.

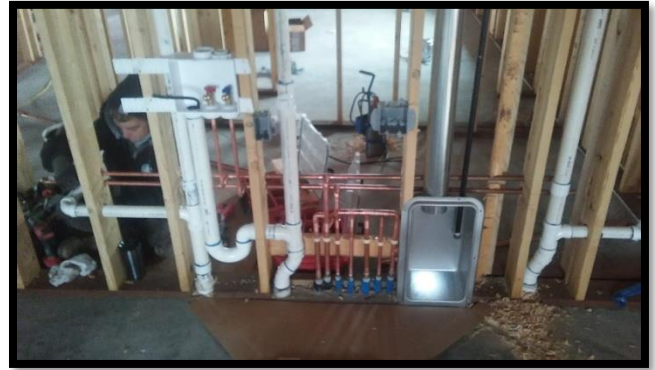
Simultaneous to the electrical rough-in, [Elsea Plumbing](#) installed copper water lines (connected to PEX in the foundation) to the bathroom, laundry room, and exterior wall hose bibs.

In addition, gas lines were run to the kitchen (gas range) and patio (gas grill). If a future owner desires gas for a dryer in the laundry room or a gas hotwater heater in the mechanical room, lines were stubbed out to these locations but will not be connected to any appliances.

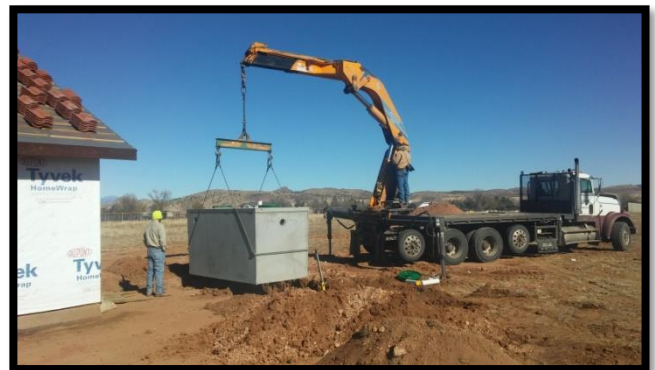
This house location is not proximal to a municipal sewer line, so a septic system was the alternative for waste water treatment/disposal. This system had been previously designed and permitted through Yavapai County Environmental Services. The soil type at the site allows for the construction of a standard septic system i.e., 1250 gallon

concrete tank and two leach trenches each 75 ft long. [Savage Development](#) was contracted to perform the excavation, set the tank, backfill with leach rock, and set the drain lines.

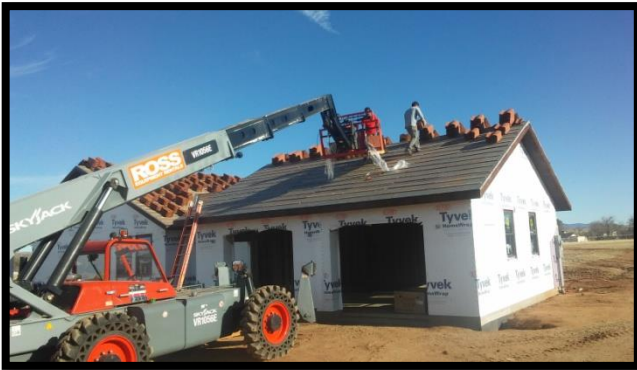
The roofing material scheduled for installation in this house is concrete S-tile. To allow the roof and other framing members to settle under the load of the tiles (especially important to limit cracking of with stucco cladding), workers from [Superior Roofing of Northern Arizona](#) distributed stacks of

tiles across the entire roof area.
