“The Path to Performance”

Postings from a 2016 Energy Star Home Under Construction

HVAC, Electrical, and Plumbing ... Installation of Essential Infrastructure in a High-performance Home

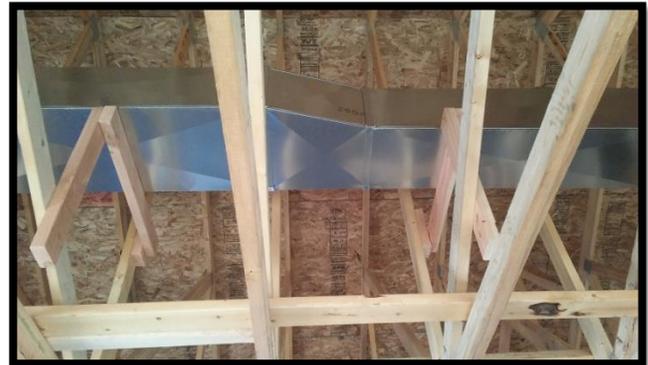
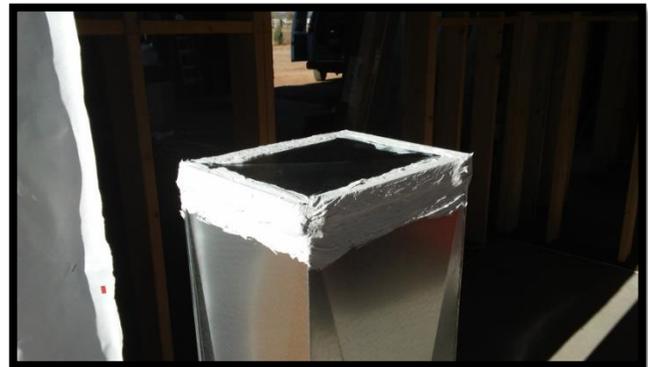
The ductwork and air handler portion of the split system was installed into what will be an unvented, conditioned attic space by technicians from [Cool Side Inc.](#) The main trunk line of the ductwork was

sheetmetal with flex duct branching off to supply conditioned air to individual ceiling registers throughout the house. Two air return plenums (master bedroom and service hallway) were also installed. Even though the ducts are in the conditioned attic space, all seams and connections

were sealed with mastic to limit air leakage that could create air pressure imbalances.

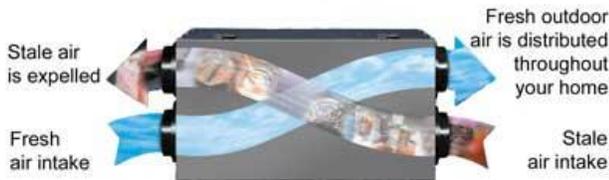
windows or other penetrations is minimized, indoor air quality must be maintained by other means. To accommodate this, Cool Side installed an Energy Star®-certified Venmar C12 Energy Recovery Ventilator (ERV). This unit draws in fresh air and expels stale air (from registers under the rear patio roof), while also tempering the air exchange temperature and filtering the air.

When in operation, the unit typically operates 20 minutes per hour programmed via a control unit on the wall.

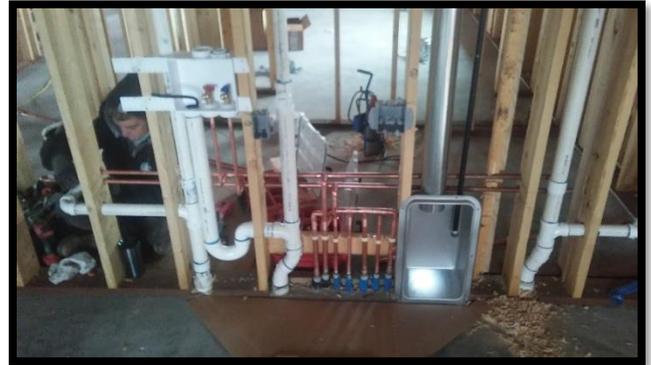
Simultaneous to the electrical rough-in, [Elsea Plumbing](#) installed copper water lines (connected to PEX in the foundation) to the bathroom, laundry room, and exterior wall hose bibs.

In addition, gas lines were run to the kitchen (gas range) and patio (gas grill). If a future owner desires gas for a dryer in the laundry room or a gas hotwater heater in the mechanical room, lines were stubbed out to these locations but will not be connected to any appliances.

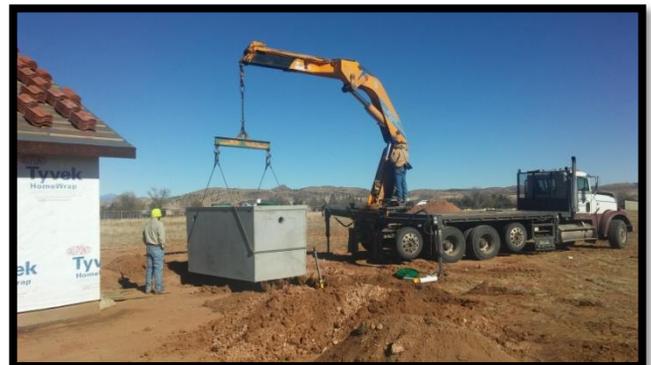
This house location is not proximal to a municipal sewer line, so a septic system was the alternative for waste water treatment/disposal. This system had been previously designed and permitted through Yavapai County Environmental Services. The soil type at the site allows for the construction of a standard septic system i.e., 1250 gallon

concrete tank and two leach trenches each 75 ft long. [Savage Development](#) was contracted to perform the excavation, set the tank, backfill with leach rock, and set the drain lines.

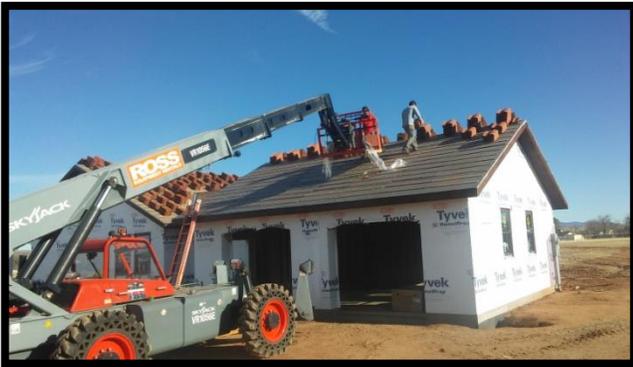
The roofing material scheduled for installation in this house is concrete S-tile. To allow the roof and other framing members to settle under the load of the tiles (especially important to limit cracking of with stucco cladding), workers from [Superior Roofing of Northern Arizona](#) distributed stacks of

tiles across the entire roof area.
