“The Path to Performance”

Postings from a 2016 Energy Star Home Under Construction in Chino Valley, Arizona

Controlling the Heat Flow and Air Flow in a High-performance Home

(December 11, 2016 – January 20, 2017)

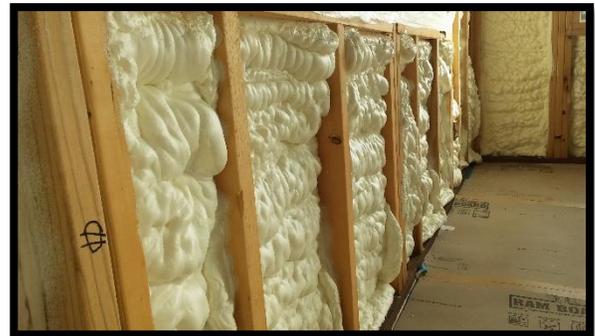
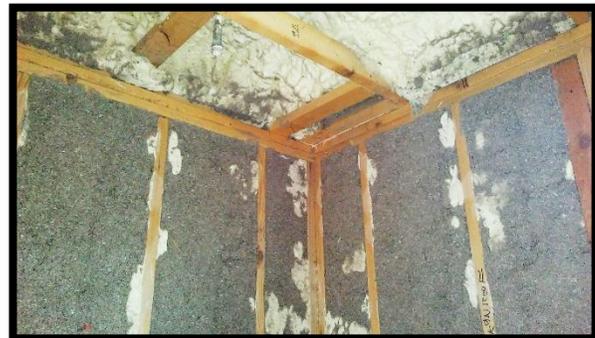
- 3 inches of PSF in the exterior 2 x 6 wall cavities. Besides being highly insulative (R value of 4.0 per inch), the PSF also achieves superb air sealing of any gaps, cracks, or holes in framing or other wall penetrations (these holes leading to uncontrolled air flow and associated negative effects). Filling the remaining 2-1/2” of the wall cavity would be wet-spray blown-in cellulose

insulation that also has excellent sound deadening qualities. This two-part approach, also termed “flash and fill”, results in a highly insulated wall system (R-21 cavity insulation, not including the exterior rigid insulation soon to be

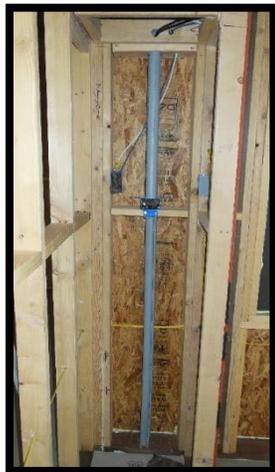
Prior to placing insulation (i.e., while the wall framing was still open and accessible), the homeowner developed and implemented a structured wiring plan i.e., data, tv, phone, and video lines. Structured wiring runs (Cat 5e and RG-11 cable) began at a media panel located in the mechanical room, branched out throughout the entire home and terminated at wall junction boxes. When the home is completed, the modem, router and ethernet switch in the media panel will provide reliable internet connections (in addition to wireless), and other lines will be available for satellite TV and video home security.

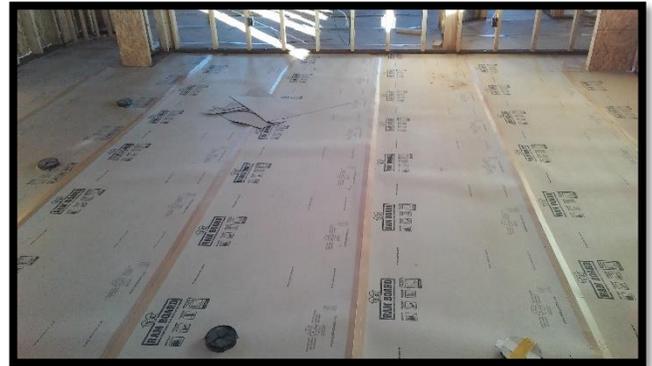
Since the homeowner is planning on stained concrete as the finished floor surface, the homeowner made an extra effort to protect that

floor from inevitable messes expected to be made in the process of insulating, drywalling, painting and the routine worker muddy boots in and out of the house. A rolled heavy-duty cardboard (Ramboard) was laid down by the homeowners over the entire concrete slab, including the garage... so far, the product is doing its job!

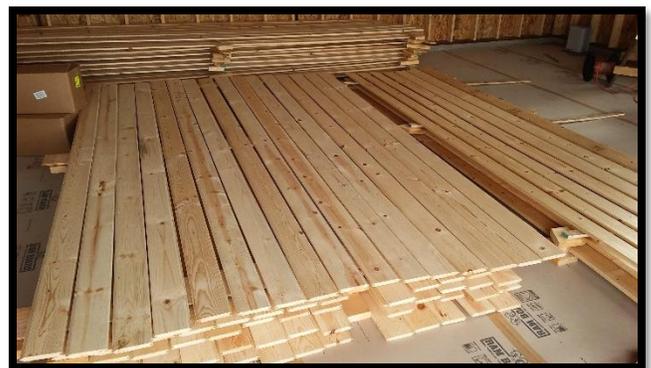
As work proceeded on the interior of the home, tongue-in-groove “cactus pine” was delivered for installation in the patio ceilings. Upon delivery, the material was protected from getting wet by stacking

it in the garage and covering it. The homeowners then proceeded to apply a protective finish coat to all 6 sides of the material (even though the patios will not be in the direct path of rain or sun). The framing

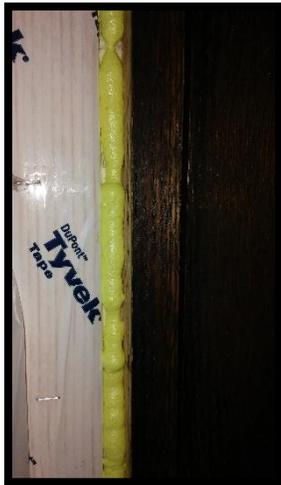
Insulated fiberglass exterior doors and solid wood (alder) interior doors were delivered and installed in January to further close in the home. The homeowner had also constructed a custom solid oak

entry door that was installed. Local craftsman [Keith Mion](#) assisted the homeowner in these door installation efforts. After these installations, the homeowner further enhanced the home’s air tightness by sealing the gaps around windows and exterior doors with low-expanding foam and/or caulk. Elimination of air leakage will lead to a more comfortable and energy efficient home.

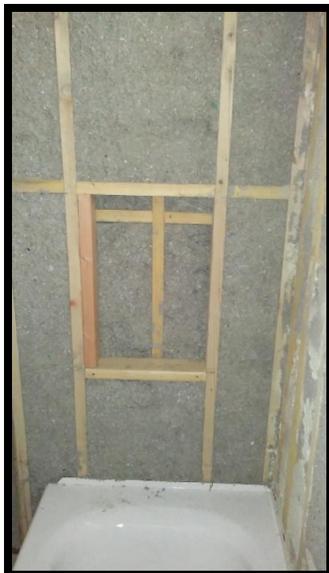
Another mundane but necessary chore completed by the homeowner prior to the installation of insulation (again, while the walls are still open) was locating and installing blocking. This blocking provided a secure backing into which hardware for cabinets, towel bars, barn doors, range hood, and wall-mounted TV can be secured.

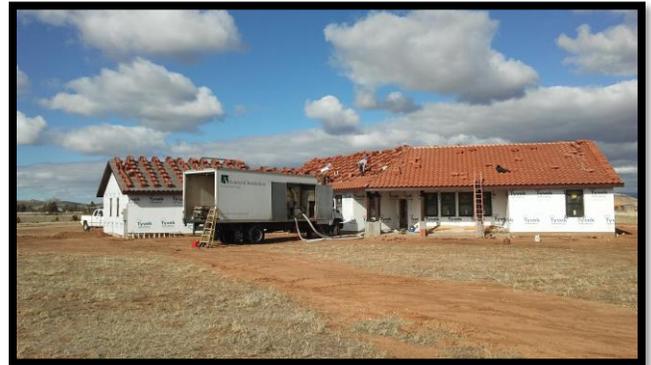
After stacking concrete tiles on the roof in December so that the trusses would settle, crews from [Superior Roofing of Northern Arizona](#) returned to lay out the tiles including ridges and gable ends.
