## “The Path to Performance”

### Postings from a 2016 Energy Star Home Under Construction in Chino Valley, Arizona

#### ***Controlling the Heat Flow and Air Flow in a High-performance Home***

(December 11, 2016 – January 20, 2017)

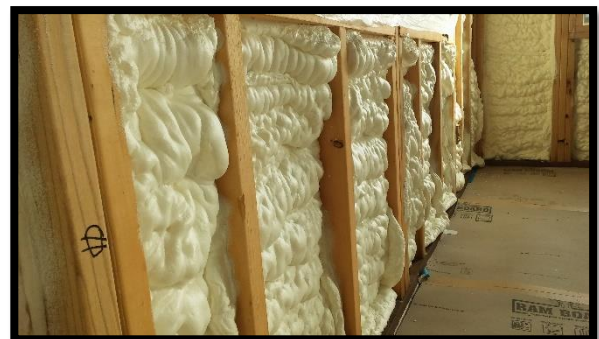
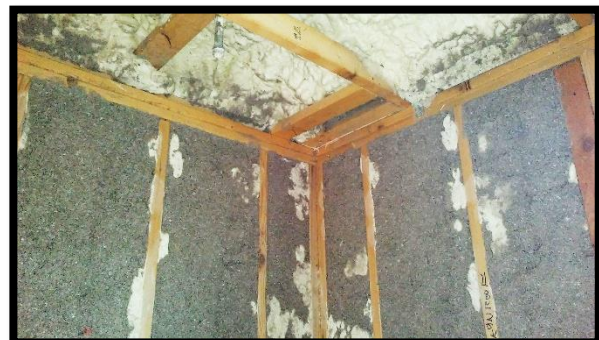
- 3 inches of PSF in the exterior 2 x 6 wall cavities. Besides being highly insulative (R value of 4.0 per inch), the PSF also achieves superb air sealing of any gaps, cracks, or holes in framing or other wall penetrations (these holes leading to uncontrolled air flow and associated negative effects). Filling the remaining 2-1/2” of the wall cavity would be wet-spray blown-in cellulose

insulation that also has excellent sound deadening qualities. This two-part approach, also termed “flash and fill”, results in a highly insulated wall system (R-21 cavity insulation, not including the exterior rigid insulation soon to be

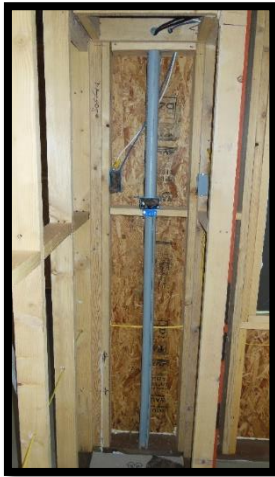
Prior to placing insulation (i.e., while the wall framing was still open and accessible), the homeowner developed and implemented a structured wiring plan i.e., data, tv, phone, and video lines. Structured wiring runs (Cat 5e and RG-11 cable) began at a media panel located in the mechanical room, branched out throughout the entire home and terminated at wall junction boxes. When the home is completed, the modem, router and ethernet switch in the media panel will provide reliable internet connections (in addition to wireless), and other lines will be available for satellite TV and video home security.

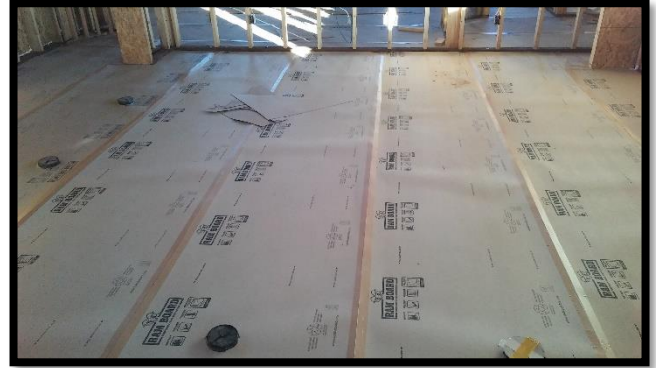
Since the homeowner is planning on stained concrete as the finished floor surface, the homeowner made an extra effort to protect that

floor from inevitable messes expected to be made in the process of insulating, drywalling, painting and the routine worker muddy boots in and out of the house. A rolled heavy-duty cardboard (Ramboard) was laid down by the homeowners over the entire concrete slab, including the garage.... so far, the product is doing its job!

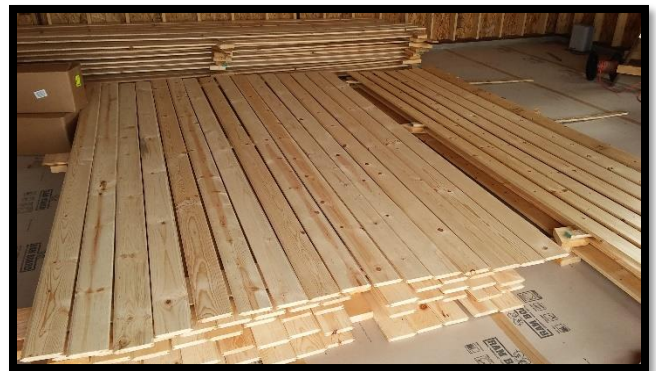
As work proceeded on the interior of the home, tongue-in-groove “cactus pine” was delivered for installation in the patio ceilings. Upon delivery, the material was protected from getting wet by stacking

it in the garage and covering it. The homeowners then proceeded to apply a protective finish coat to all 6 sides of the material (even though the patios will not be in the direct path of rain or sun). The framing

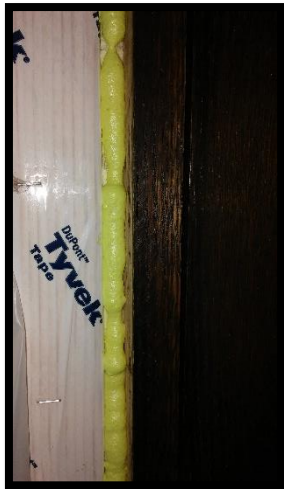
Insulated fiberglass exterior doors and solid wood (alder) interior doors were delivered and installed in January to further close in the home. The homeowner had also constructed a custom solid oak

entry door that was installed. Local craftsman [Keith Mion](#) assisted the homeowner in these door installation efforts. After these installations, the homeowner further enhanced the home’s air tightness by sealing the gaps around windows and exterior doors with low-expanding foam and/or caulk. Elimination of air leakage will lead to a more comfortable and energy efficient home.

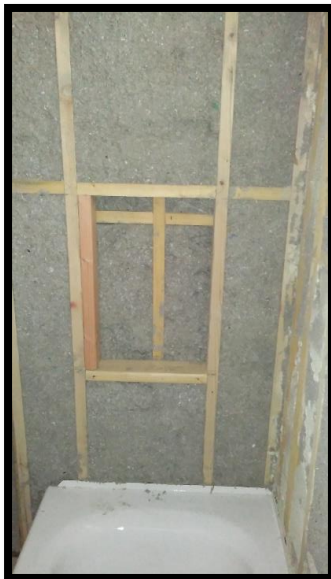
Another mundane but necessary chore completed by the homeowner prior to the installation of insulation (again, while the walls are still open) was locating and installing blocking. This blocking provided a secure backing into which hardware for cabinets, towel bars, barn doors, range hood, and wall-mounted TV can be secured.

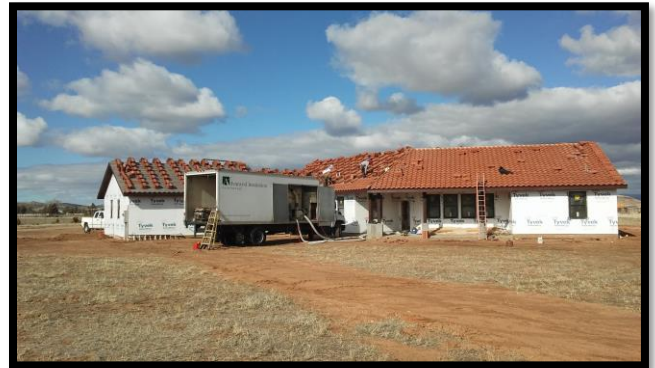
After stacking concrete tiles on the roof in December so that the trusses would settle, crews from [Superior Roofing of Northern Arizona](#) returned to lay out the tiles including ridges and gable ends.
